January 31, 1968

Final Report

## INTERACTION OF LIQUID SODIUM WITH 304 STAINLESS STEEL

SRI Project PMU 6694

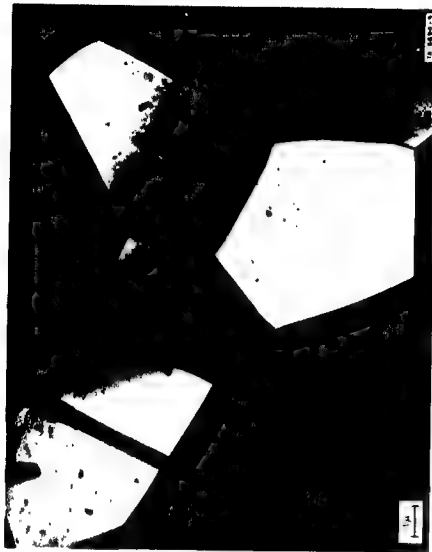
FIG. 5 TRANSMISSION ELECTRON MICROGRAPH OF 304 STAINLESS STEEL AFTER ELECTROPOLISHING

Electron micrographs of annealed 304 stainless steel foils, as electropolished, are shown in Figs. 5-7. The grains are generally equiaxed and the grain boundaries are well defined. The dislocation density in the foils is low, but numerous annealing twins are observed. The edges of the foils are very smooth after electropolishing (Fig. 6). These micrographs are typical of the 304 stainless steel foils used in all tasks of the experimental investigation.

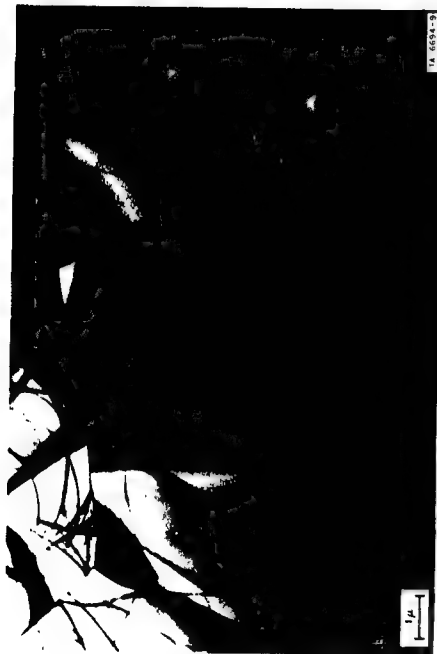
FIG. 9 TRANSMISSION ELECTRON MICROGRAPH OF 304 STAINLESS STEEL AFTER EXPOSURE TO LIQUID SODIUM AT 700°F. The micrograph reveals a thoroughly clean foil having no residual sodium. The curved black lines are extinction contours due to the bending of the foil.

A satisfactory method of removing sodium from the exposed stainless steel surface was also demonstrated in our studies. For example, an electropolished stainless steel specimen that had been immersed in a sodium bath at 700°F for 10 minutes was cleaned of all traces of any surface deposit by the Soxhlet extraction procedure described earlier. (The temperature of 700°F was determined to be the lowest temperature at which it was certain that complete wetting of the foil surface by the sodium was achieved). Fig. 9 is an example of such a foil. No residue is seen on the surface or at the grain boundaries. In fact, the foil appears as clean, if not cleaner, than a freshly electropolished foil. In light of subsequent observations, the efficiency of the cleaning technique to remove all sodium (or sodium oxide) from the foil surface was very important.

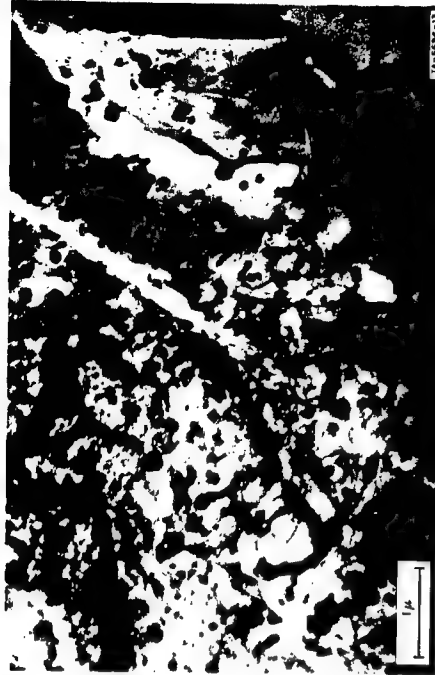
FIG. 13 TRANSMISSION ELECTRON MICROGRAPH OF 304 STAINLESS STEEL FOIL AFTER ELEVEN HOURS EXPOSURE TO LIQUID SODIUM AT 1200°F. Structure shows a severely attacked foil.

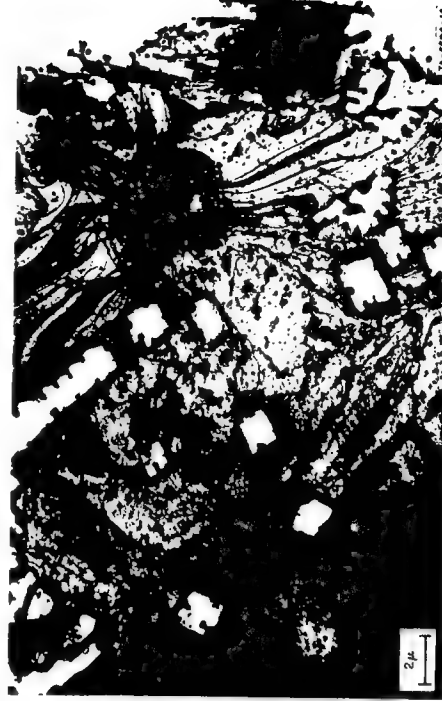
FIG. 14 TRANSMISSION ELECTRON MICROGRAPH OF 304 STAINLESS STEEL FOIL AFTER FIFTEEN HOURS EXPOSURE TO LIQUID SODIUM AT 950°F. Micrograph shows holes etched in surface by liquid sodium. The very ragged edge of the foil has also been severely attacked.

deposited on almost all the grains, appears dark because it is thick enough to absorb all the electrons that otherwise would pass through the foil. The deposit always has a geometrical shape, which varies from grain to grain, often a grain is heavily deposited, but a twinned section of the same grain is relatively free of deposit. So far it has not been possible to identify this deposit by transmission electron diffraction. In view of the fact that stainless steel foils can be cleaned so successfully after exposure to liquid sodium at and below 700°F, it is felt that this precipitate is neither sodium nor sodium oxide. One grain boundary shown in Fig. 10 has been attacked by the liquid sodium. Rather large holes with very ragged edges can also be seen in this micrograph. These holes may well have been small pinholes in the electropolished foil (Fig. 6) that have been enlarged by attack of the liquid sodium metal. The grain boundary attack can be more clearly seen in Fig. 11, which is a higher magnification micrograph of the same area of the foil. Only a few of the grain boundaries were attacked, but no detailed orientation studies were made to determine which boundaries were involved. Figs. 12 and 13 reveal grain boundaries that have been severely attacked, leaving the edges with the characteristic ragged effect. This etching behavior is always observed at the edges of the foil: thus, a very smooth edge (Fig. 7) becomes ragged and irregular after exposure to liquid sodium at 1200°F (Figs. 14 and 15).

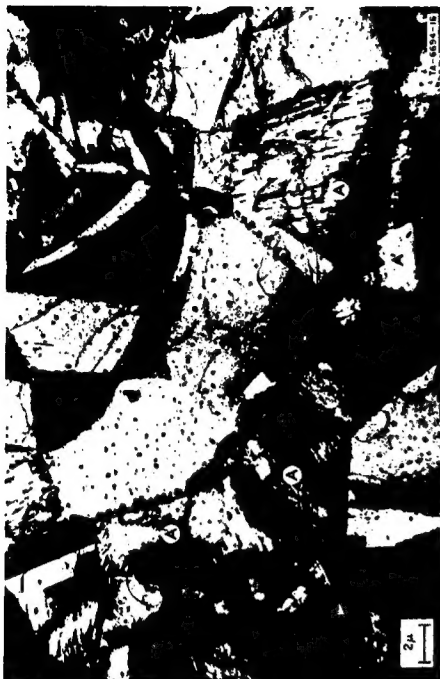
FIG. 16 TRANSMISSION ELECTRON MICROGRAPH OF 304 STAINLESS STEEL FOIL AFTER ELEVEN HOURS EXPOSURE TO LIQUID SODIUM AT 1200°F. A preferential deposit along grain boundaries is evident throughout. Sections of some grains have fairly heavy surface deposits (A), whereas twinned sections of the same grains are relatively clean (A').

The nature of the residual surface precipitate can vary greatly from one experiment to the next. This is clearly seen by contrasting the structures in Figs. 15 and 16. In Fig. 16, most grains are relatively free of this deposit, only a few grains having a surface precipitate. This figure illustrates the dependence of the precipitate upon the orientation of the stainless steel grain. A section of a given foil is free of precipitate but a twinned section of the same grain is heavily deposited. Another striking observation in this micrograph is the preferential deposit of the precipitate along grain boundaries. A higher magnification micrograph of the same foil, Fig. 17, clearly illustrates this. At times, the precipitate appears to be deposited totally within the grain boundary. This is shown in Fig. 18, which also reveals that the twin boundaries remain clean. This lack of deposit in or at twin boundaries is always observed.

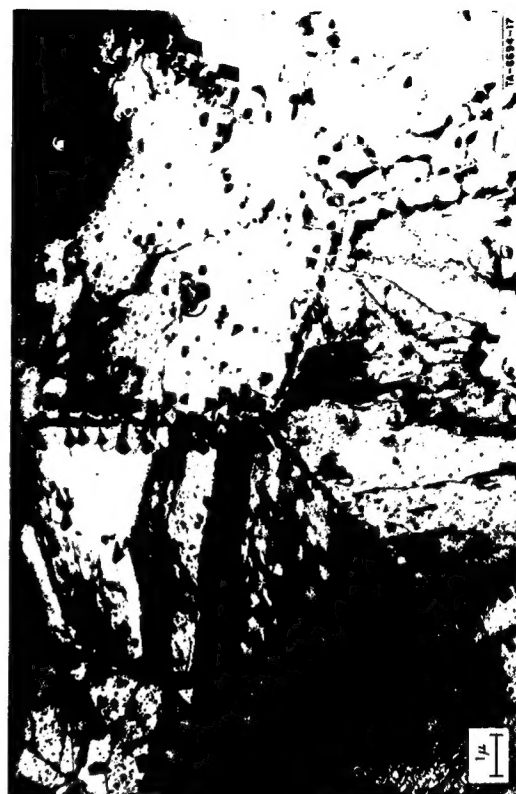
FIG. 17 TRANSMISSION ELECTRON MICROGRAPH OF 304 STAINLESS STEEL FOIL AFTER ELEVEN HOURS EXPOSURE TO LIQUID SODIUM AT 1200°F. Micrograph clearly shows geometrical grain boundary precipitate.

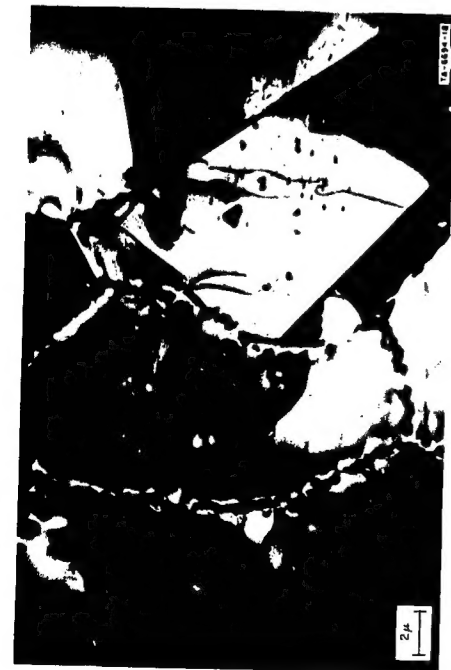
FIG. 18 TRANSMISSION ELECTRON MICROGRAPH OF 304 STAINLESS STEEL FOIL AFTER ELEVEN HOURS EXPOSURE TO LIQUID SODIUM AT 1200°F. Structure shows selective grain boundary precipitate. Note that the twin boundaries are free of deposit.

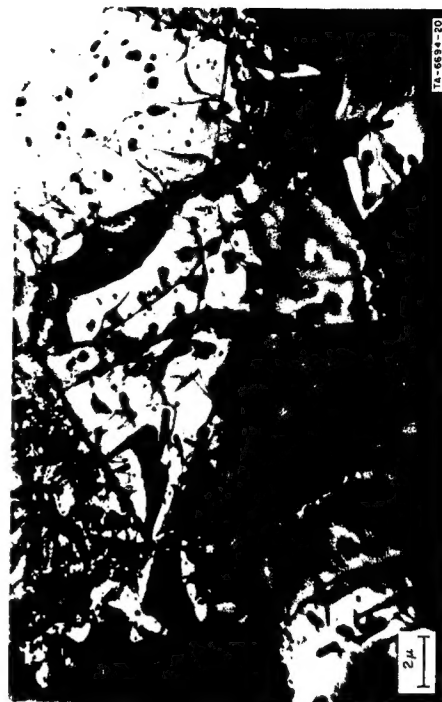
FIG. 20 TRANSMISSION ELECTRON MICROGRAPH OF 304 STAINLESS STEEL FOIL AFTER SIX HOURS EXPOSURE TO LIQUID SODIUM AT 1200°F. Heavy deposits occur on surface and at grain boundaries.

Fig. 19 shows a region of an exposed foil that is relatively free of both surface and grain boundary deposit, compared with the structure in Fig. 20. Foils such as that in Fig. 19 have, after initial cleaning and examination, received a second and more vigorous cleaning without reducing the amount of deposit observed. Variations in surface deposits therefore are not solely attributable to the efficiency of the cleaning technique.
